RARITAN RIVER BASIN
RAHWAY RIVER, UNION COUNTY
NEW JERSEY

BLOODGOODS POND DAM

NJ 00370

PHASE 1 INSPECTION REPORT NATIONAL DAM SAFETY PROGRAM

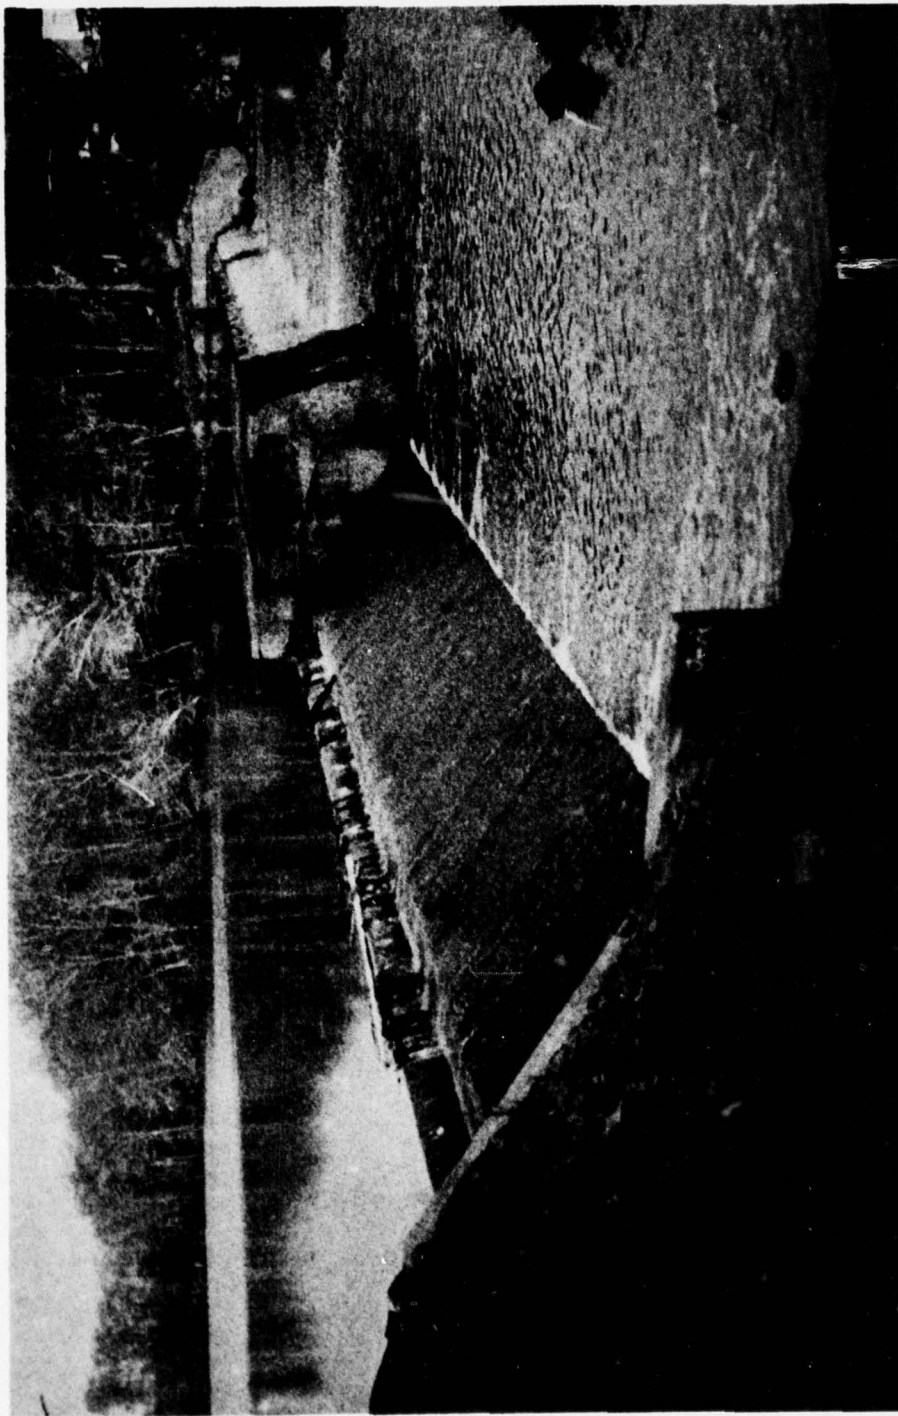
OVERVIEW OF BLOODGOOD'S POND DAM

Bloodgoods Pond Dam is in a poor overall condition. Uncertainty with respect to the configuration of the original slab and buttress spillway necessitates additional site investigations and engineering studies to ascertain continued stability at design flood elevations. Remedial actions recommended to be undertaken in the near future are:

- (1) Replacement of existing concrete flood-gate structure, original spillway, and left wingwall;
- (2) Repair of the inoperable 30" sluice gate;
- (3) Improvement of the drawdown capacity.
